Pineae Village Condominium Association

Level 2 Reserve Study

Report Period – 01/01/2022 – 12/31/2022

Type of Study	Update w/Site Visit
Date of Property Inspection	8/26/2021
Prepared By	Dale Gifford
Analysis Method	Cash Flow
Funding Goal	Full Funding

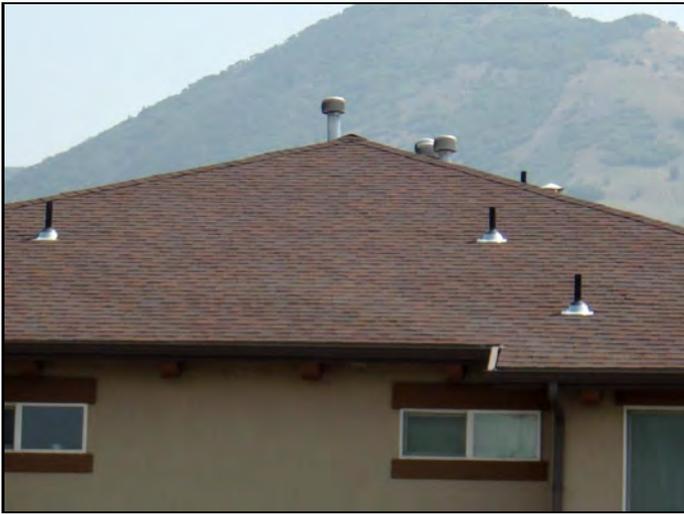
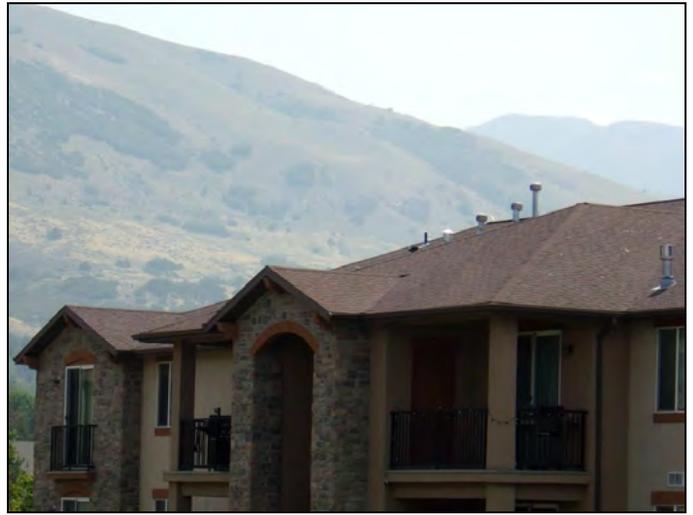
Comp #: 105 Roofs - 2009-10 - Replace

Location: **Building Roofs**

The roofs are in good condition. We recommend funding to replace this component approximately every 20 - 25 years. Remaining life based on current average age.

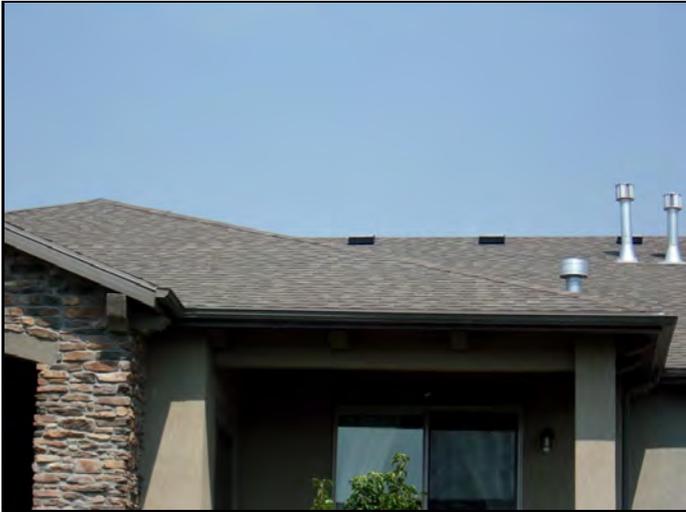
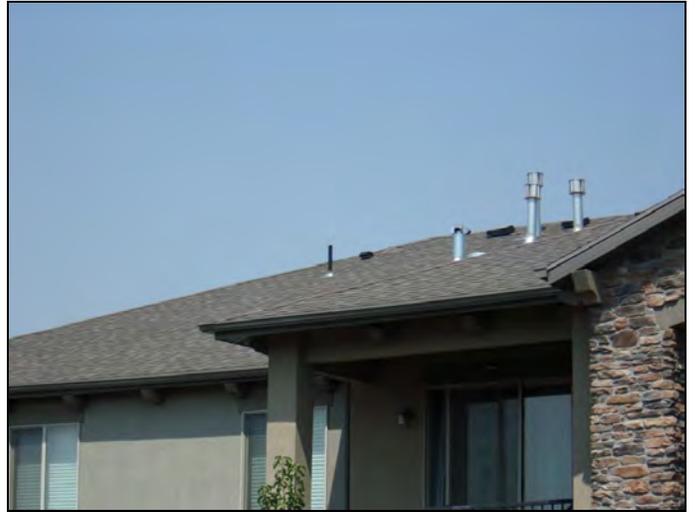
Comp #: 105 Roofs - 2013-14 - Replace

Location: **Building Roofs**

The roofs are in good condition. We recommend funding to replace this component approximately every 20 - 25 years. Remaining life based on current average age.

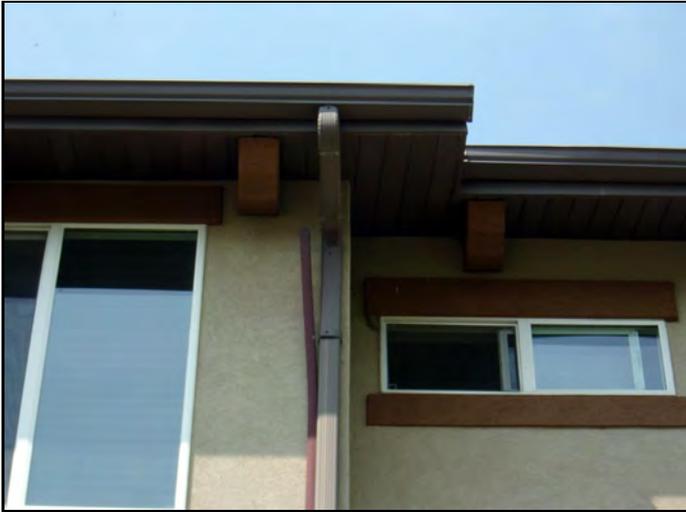
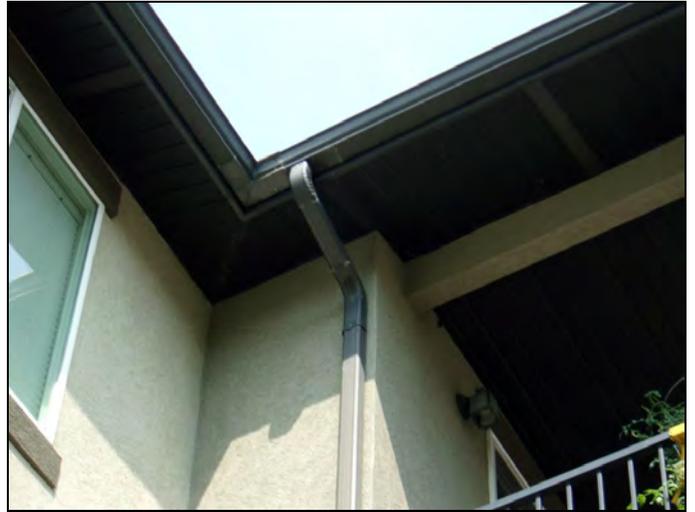
Comp #: 120 Rain Gutters/Downspouts - 2009-10 - Replace

Location: **Building Roofs**

The rain gutters and downspouts are in good condition. We recommend funding to replace this component approximately every 25 - 30 years. Remaining life based on average age.

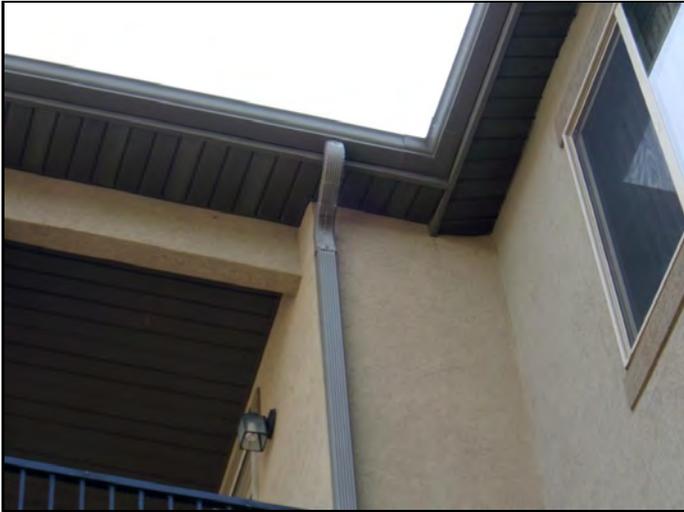
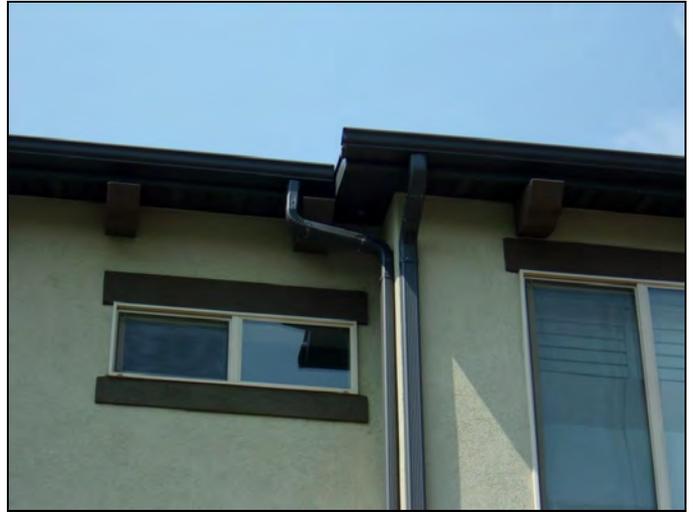
Comp #: 120 Rain Gutters/Downspouts - 2013-14 - Replace

Location: **Building Roofs**

The rain gutters and downspouts are in good condition. We recommend funding to replace this component approximately every 25 - 30 years. Remaining life based on average age.

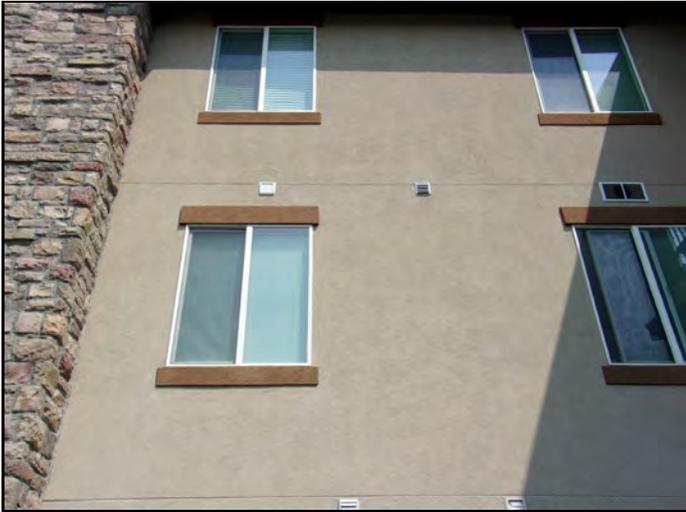
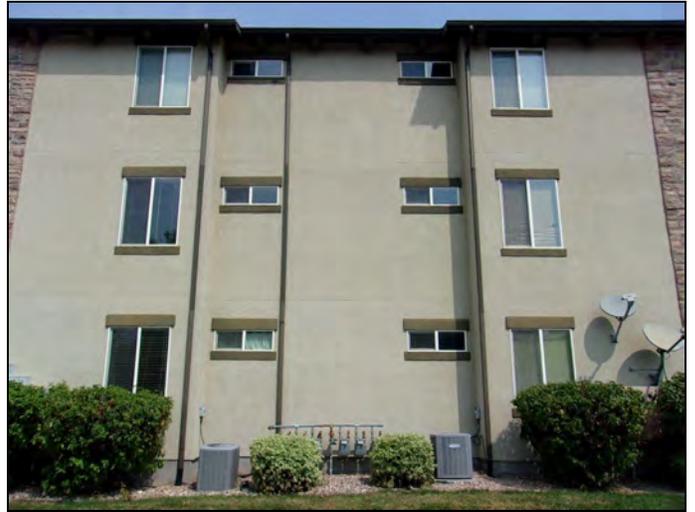
Comp #: 201 Stucco Surfaces - 2009-10 - Repair/Repaint

Location: **Building Exteriors**

The stucco surfaces are in good to fair condition. We recommend funding to repair/repaint this component approximately every 12 - 15 years. Remaining life based on average age.

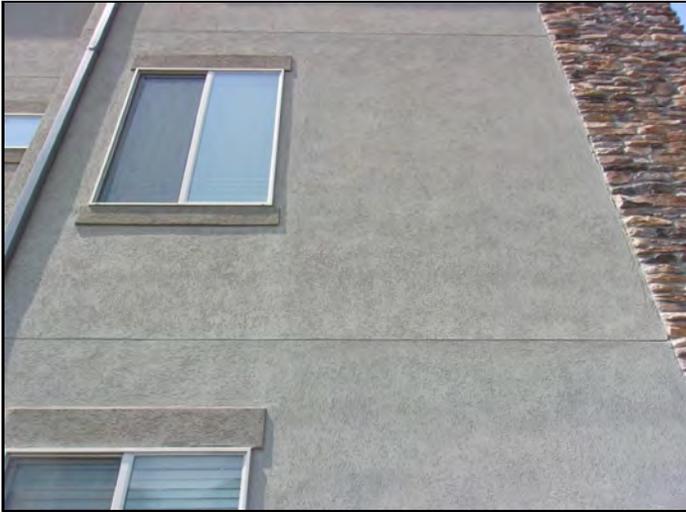
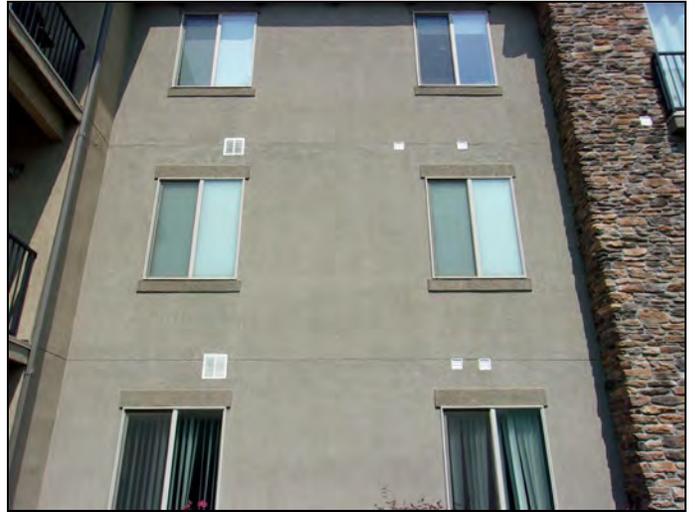
Comp #: 201 Stucco Surfaces - 2013-14 - Repair/Repaint

Location: **Building Exteriors**

The stucco surfaces are in good condition. We recommend funding to repair/repaint this component approximately every 12 - 15 years. Remaining life based on average age.

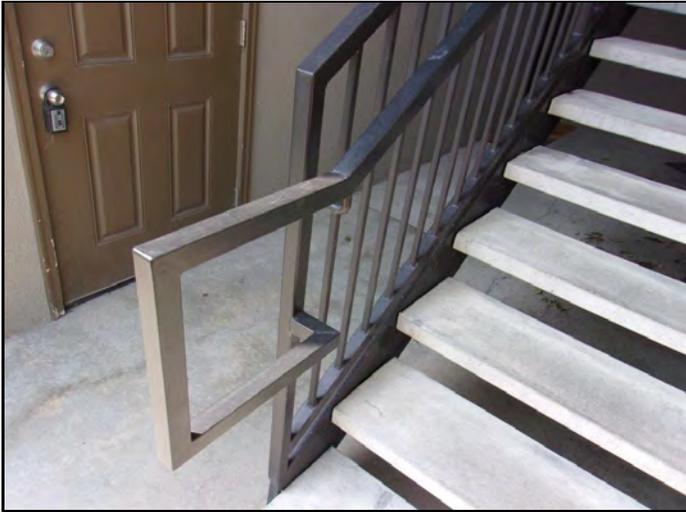
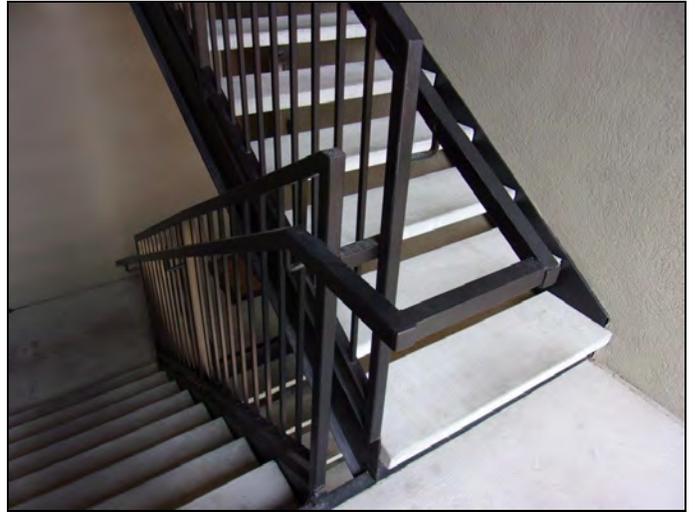
Comp #: 212 Metal Railing - 2009-14 - Repaint

Location: **Building Stairwells**

The painted metal railing surfaces are in fair to poor condition. We recommend funding to paint this component approximately every 6 years. Remaining life based on current condition.

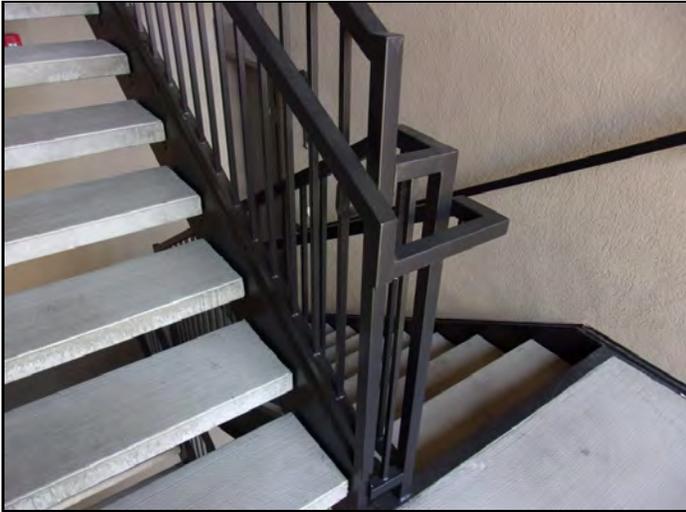
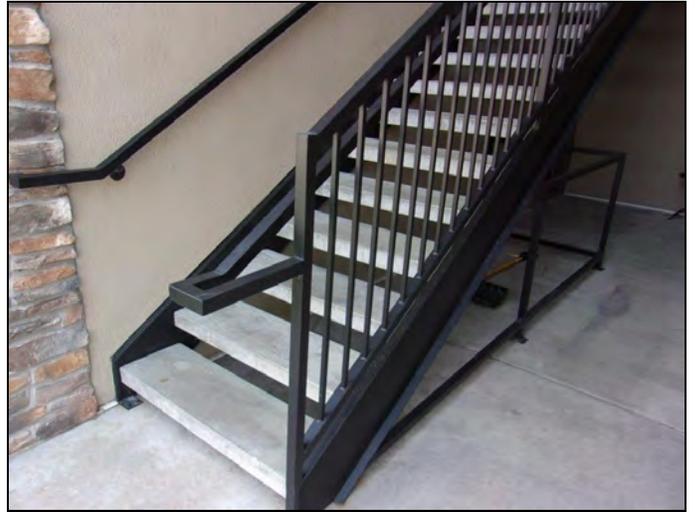
Comp #: 212 Metal Railing - 2017 - Repaint

Location: **Building Stairwells**

The painted metal railing surfaces are in good to fair condition. We recommend funding to paint this component approximately every 6 years. Remaining life based on current age.

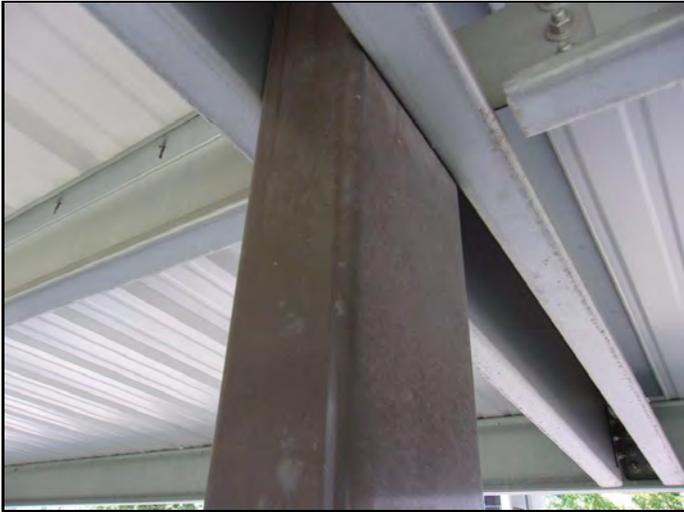
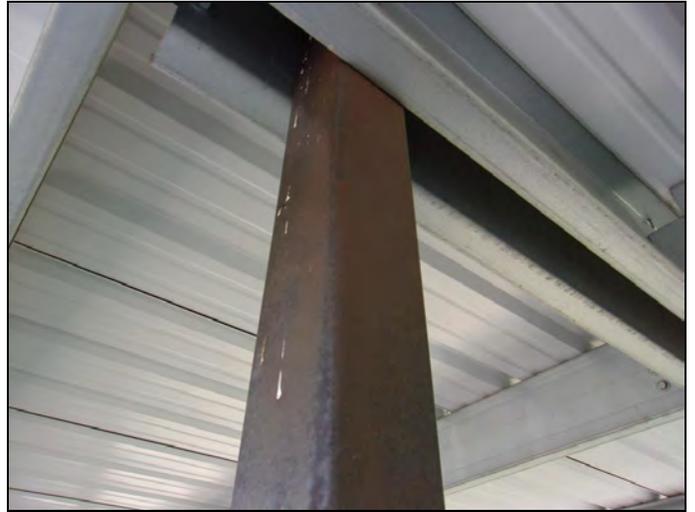
Comp #: 223 Carports - Repaint

Location: **Parking Areas**

The paint on the carport structure is in fair to poor condition. We recommend funding to repaint this component approximately every 10 - 15 years. Remaining life based on current age and condition.

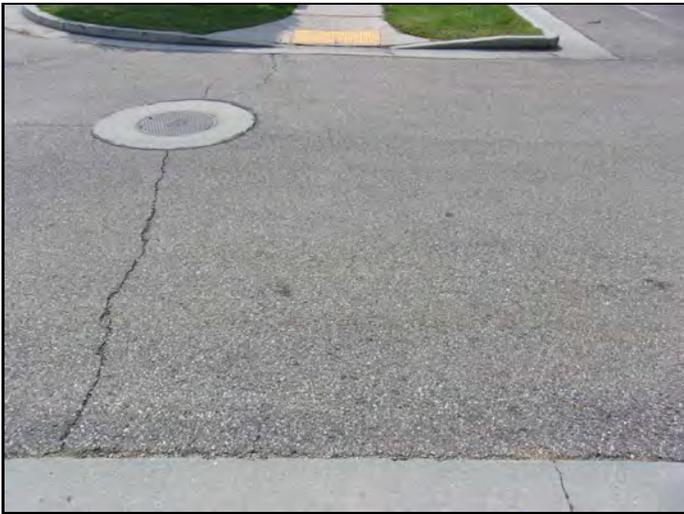
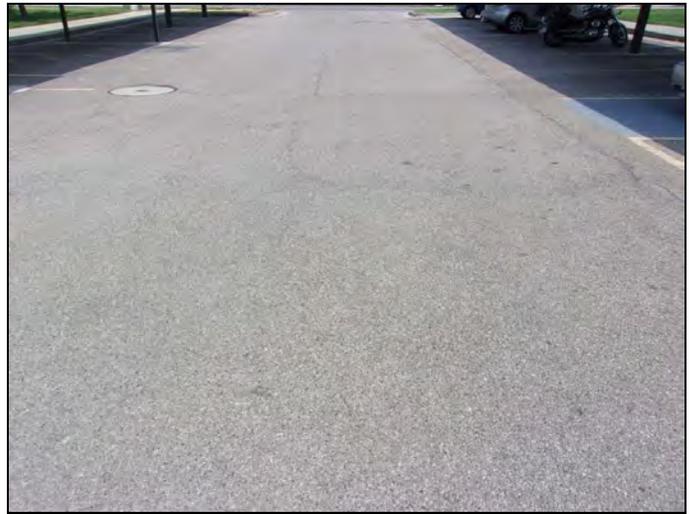
Comp #: 401 Asphalt - Major Rehab

Location: **Community Parking & Streets**

The asphalt surfaces are generally in good condition. We recommend funding for a major rehab of this component approximately every 25 - 30 years. Remaining life based on current age.

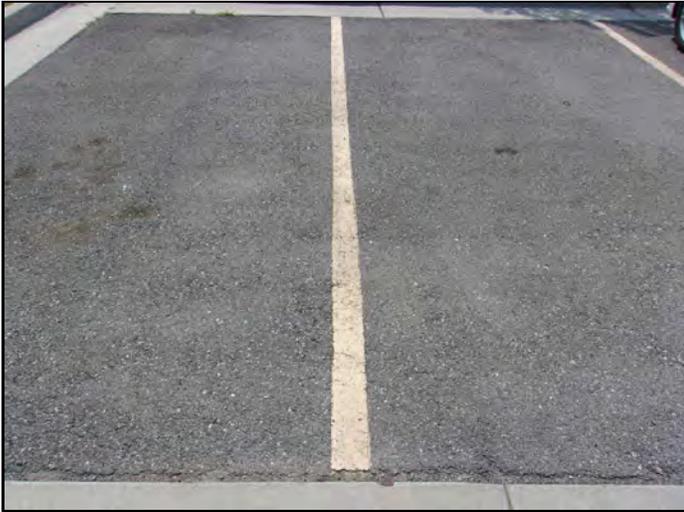
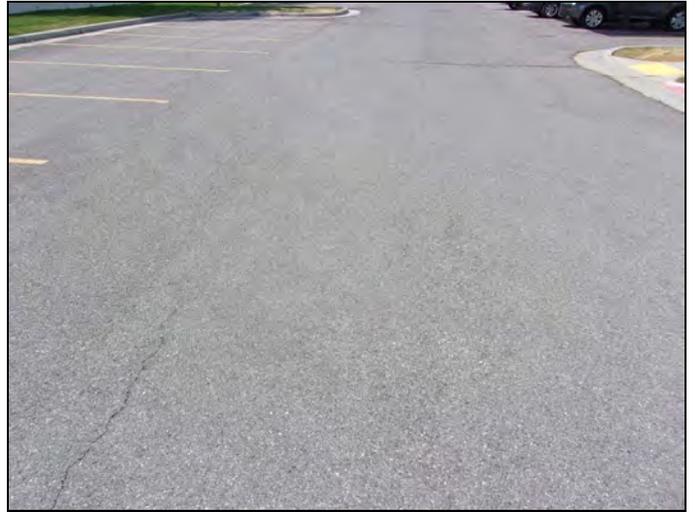
Comp #: 402 Asphalt - Seal Coat

Location: **Community Parking & Streets**

The asphalt seal coat is in poor condition. We recommend funding to seal this component approximately every 3 - 5 years. Remaining life based on current condition.

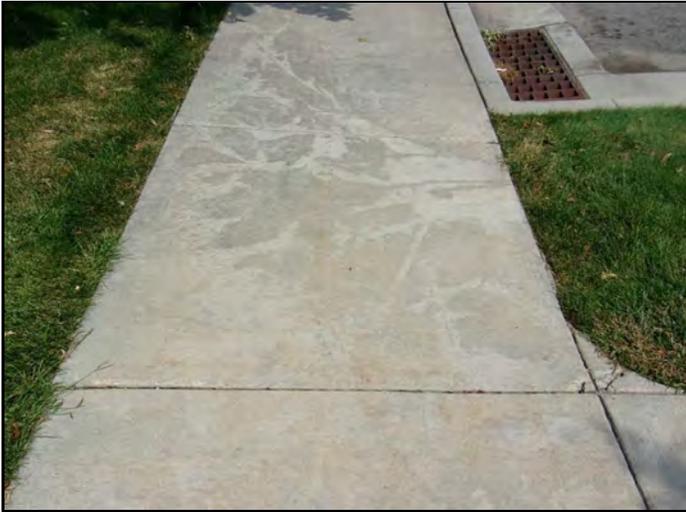
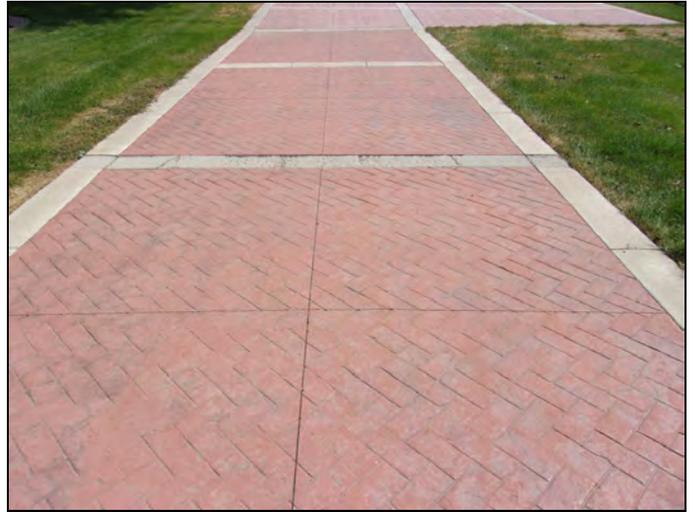
Comp #: 403 Concrete - Repair/Replace

Location: **Curb, Gutter & Sidewalks**

The concrete is in good condition. This component has an extended useful life under normal conditions. We recommend funding to make repairs and partially replace this component approximately every 10 years. Remaining life based on current age.

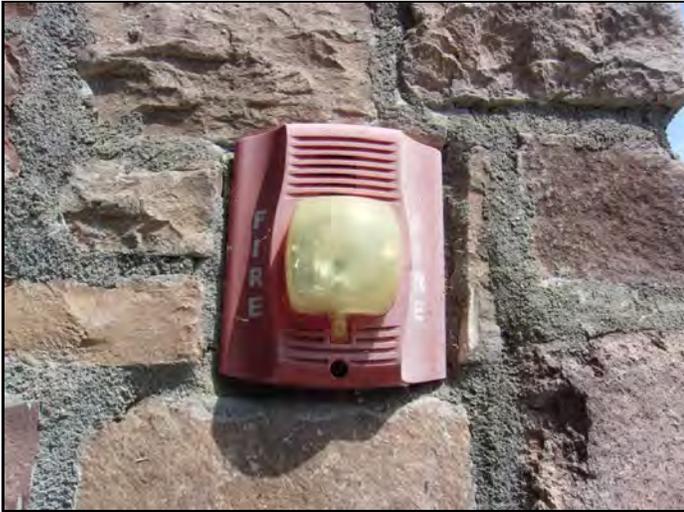
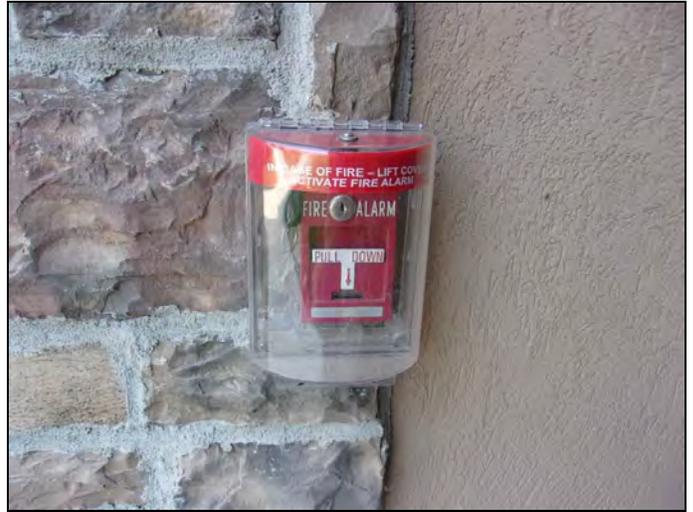
Comp #: 901 Fire Protection Systems - 2009-10 - Renovate

Location: **Buildings**

Although the fire protection system is designed to last the life of the community we recommend funding for an allowance to renovate this component approximately every 20 years to ensure proper function and to keep up with current technology and code requirements. Perform regular, professional inspections and repairs as an operating expense. Remaining life based on average age.

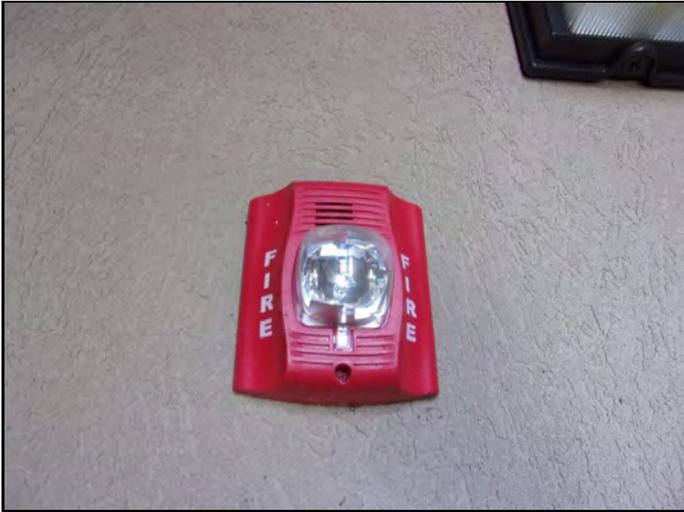
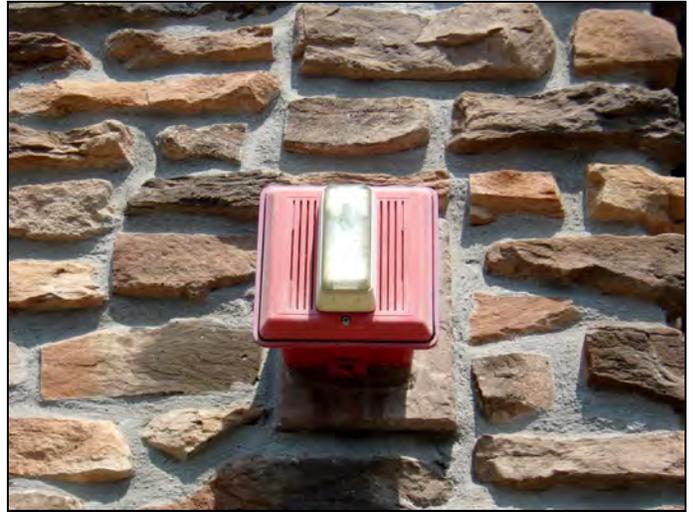
Comp #: 901 Fire Protection Systems - 2013-14 - Renovate

Location: **Buildings**

Although the fire protection system is designed to last the life of the community we recommend funding for an allowance to renovate this component approximately every 20 years to ensure proper function and to keep up with current technology and code requirements. Perform regular, professional inspections and repairs as an operating expense. Remaining life based on average age.

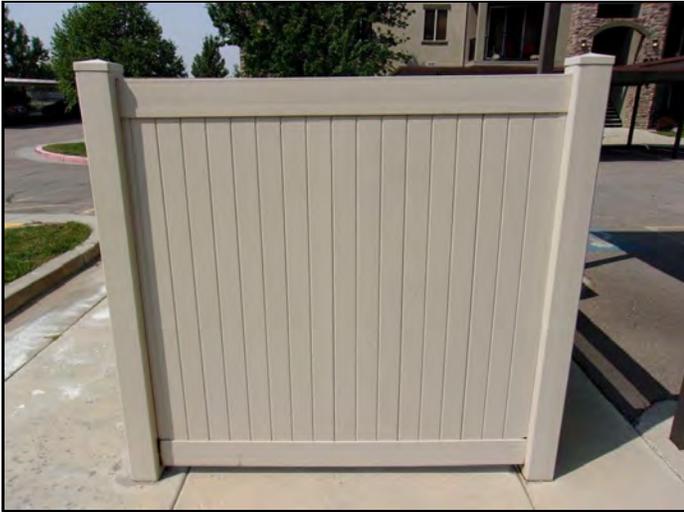
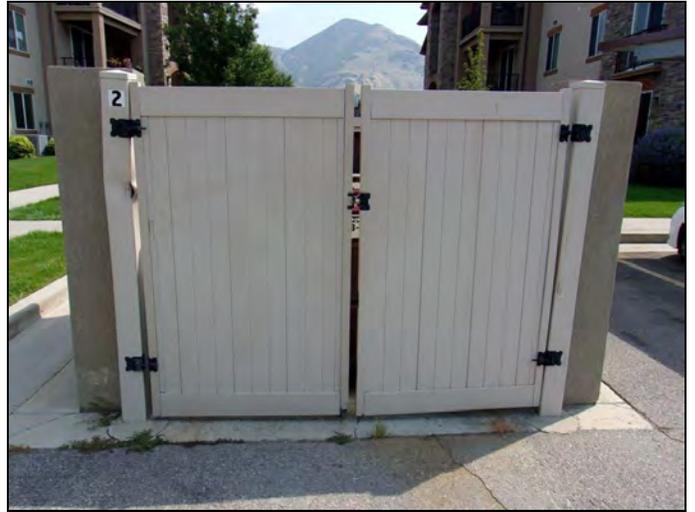
Comp #: 1090 Dumpster Enclosure Fence & Gates - Replace

Location: **Dumpster Enclosure Areas**

The fencing is generally in fair condition. We recommend funding to replace this component approximately every 20 - 25 years. Remaining life based on average age.

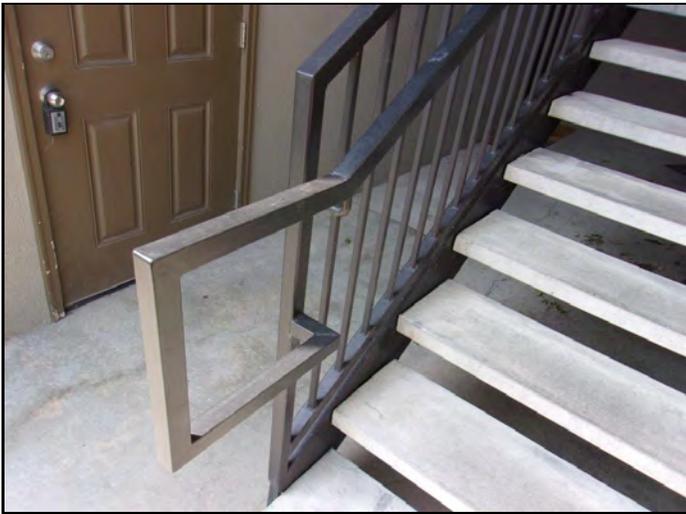
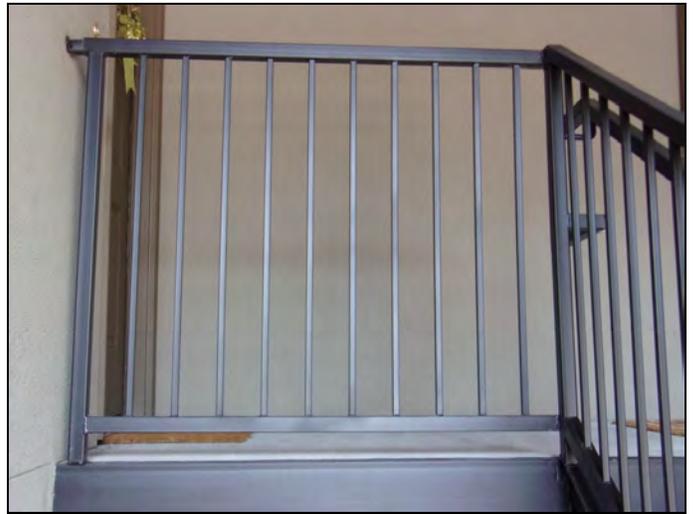
Comp #: 1090 Metal Railing - 2009-10 - Replace

Location: **Building Stairwells**

The railing is in good condition. We recommend funding to replace this component approximately every 40 - 50 years. Remaining life based on average age.

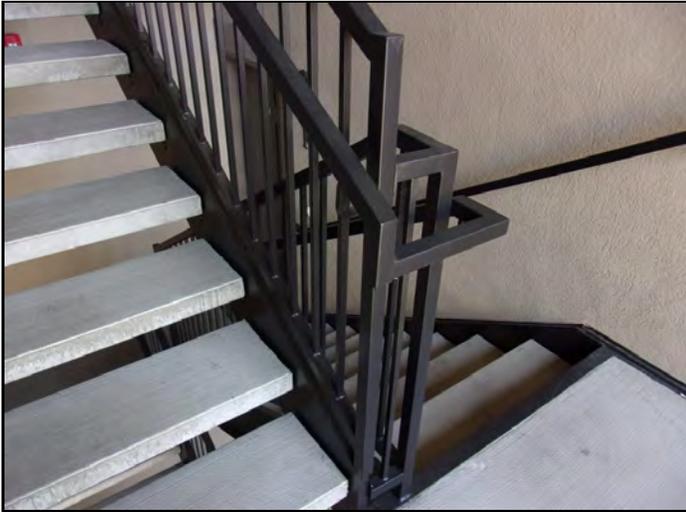
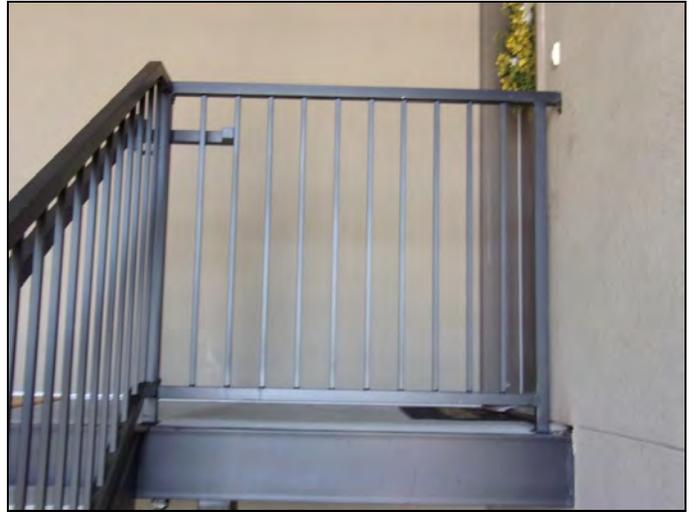
Comp #: 1090 Metal Railing - 2013-14 - Replace

Location: **Building Stairwells**

The railing is in good condition. We recommend funding to replace this component approximately every 40 - 50 years. Remaining life based on average age.

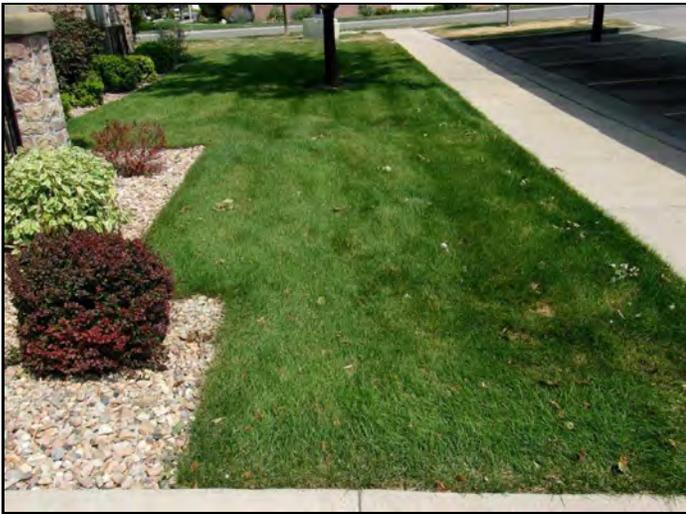
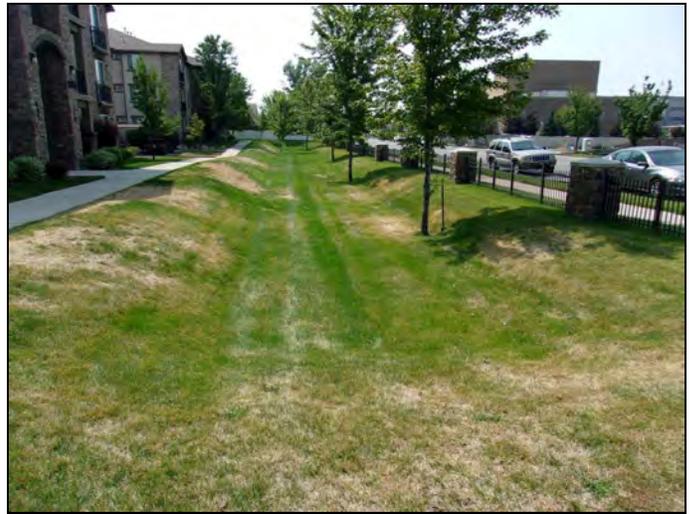
Comp #: 1812 Landscaping - Renovate

Location: **Common Area**

The landscaping and irrigation system are in good condition. We recommend funding for an allowance to renovate the landscaping and irrigation system approximately every 20 years. Remaining life based on average age.
